Sebastian Inlet Seagrass Monitoring Program

2020 Annual Seagrass Monitoring Report

Sebastian Inlet District

22 December 2020

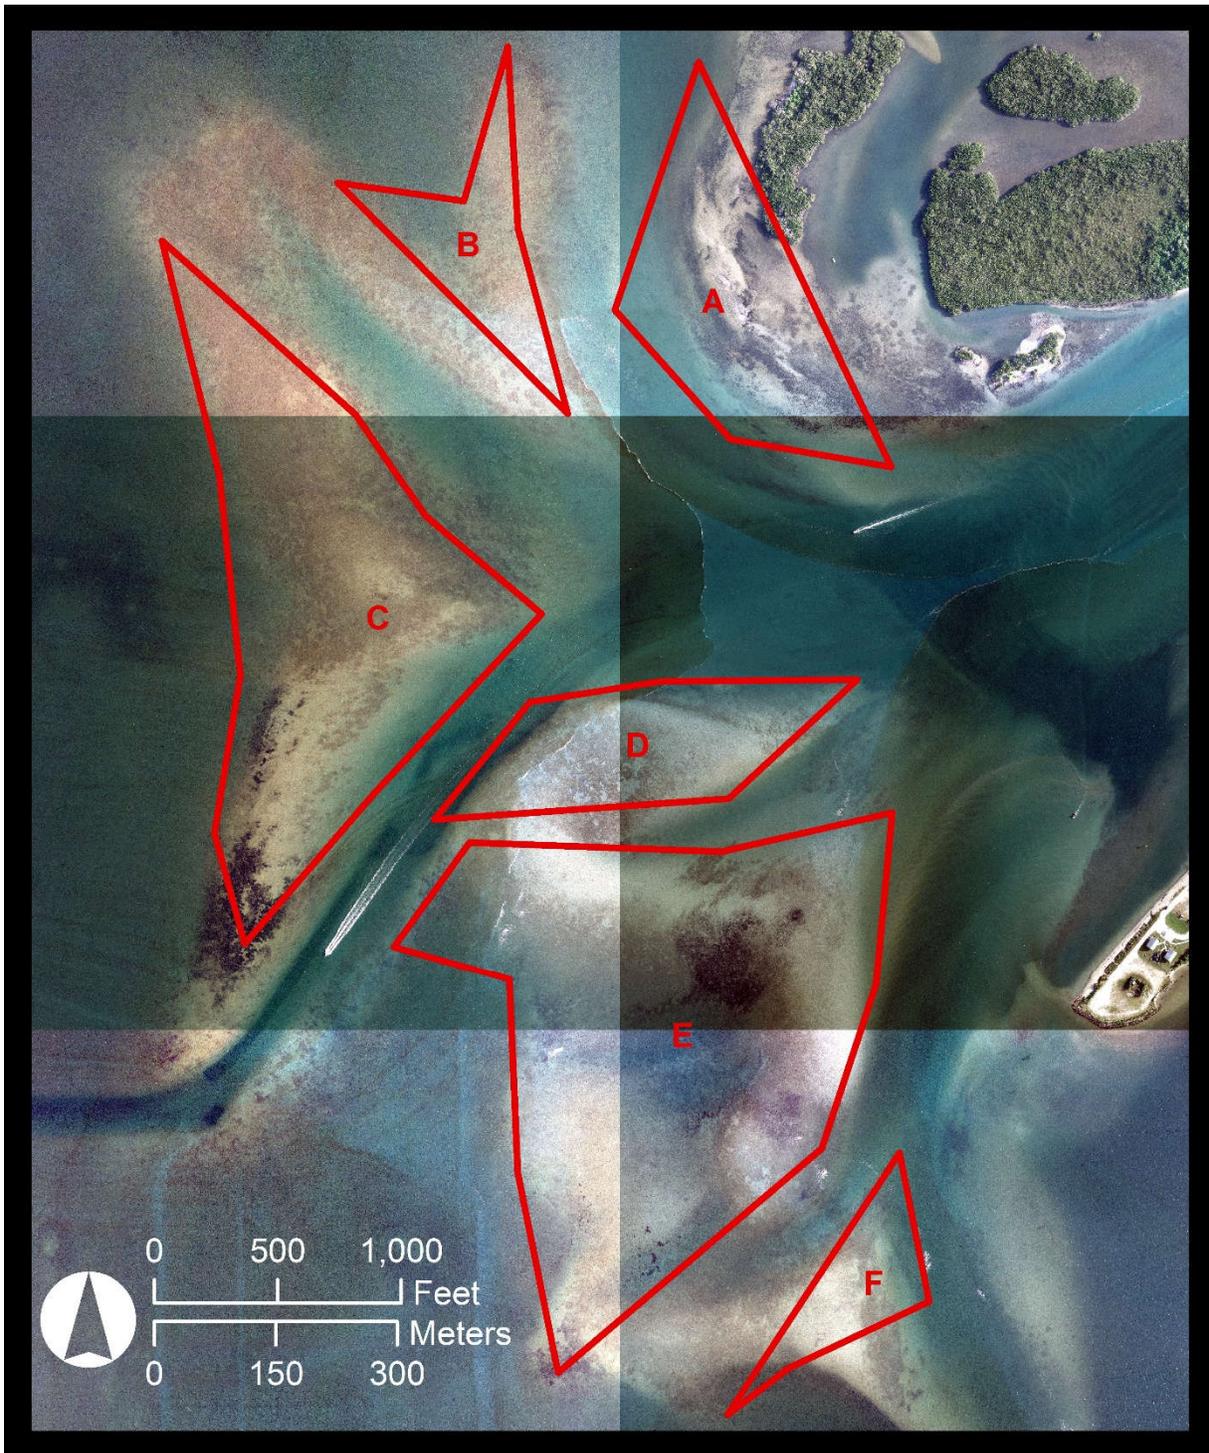
GPI Geospatial, Inc. (previously Aerial Cartographics of America, Inc.) was selected to supply low-altitude, high-resolution, color imagery for the 500-acre region of the shoal. Aerial imagery was captured on July 1, 2020 during an incoming tide. The resultant digital imagery was georectified and had an effective ground pixel resolution of 0.25 feet (Figure 2-1).

Figure 2-1 Aerial imagery of Sebastian Inlet flood tidal shoal (Florida). The image was taken on July 1, 2020 by GPI Geospatial, Inc. for the Sebastian Inlet District.

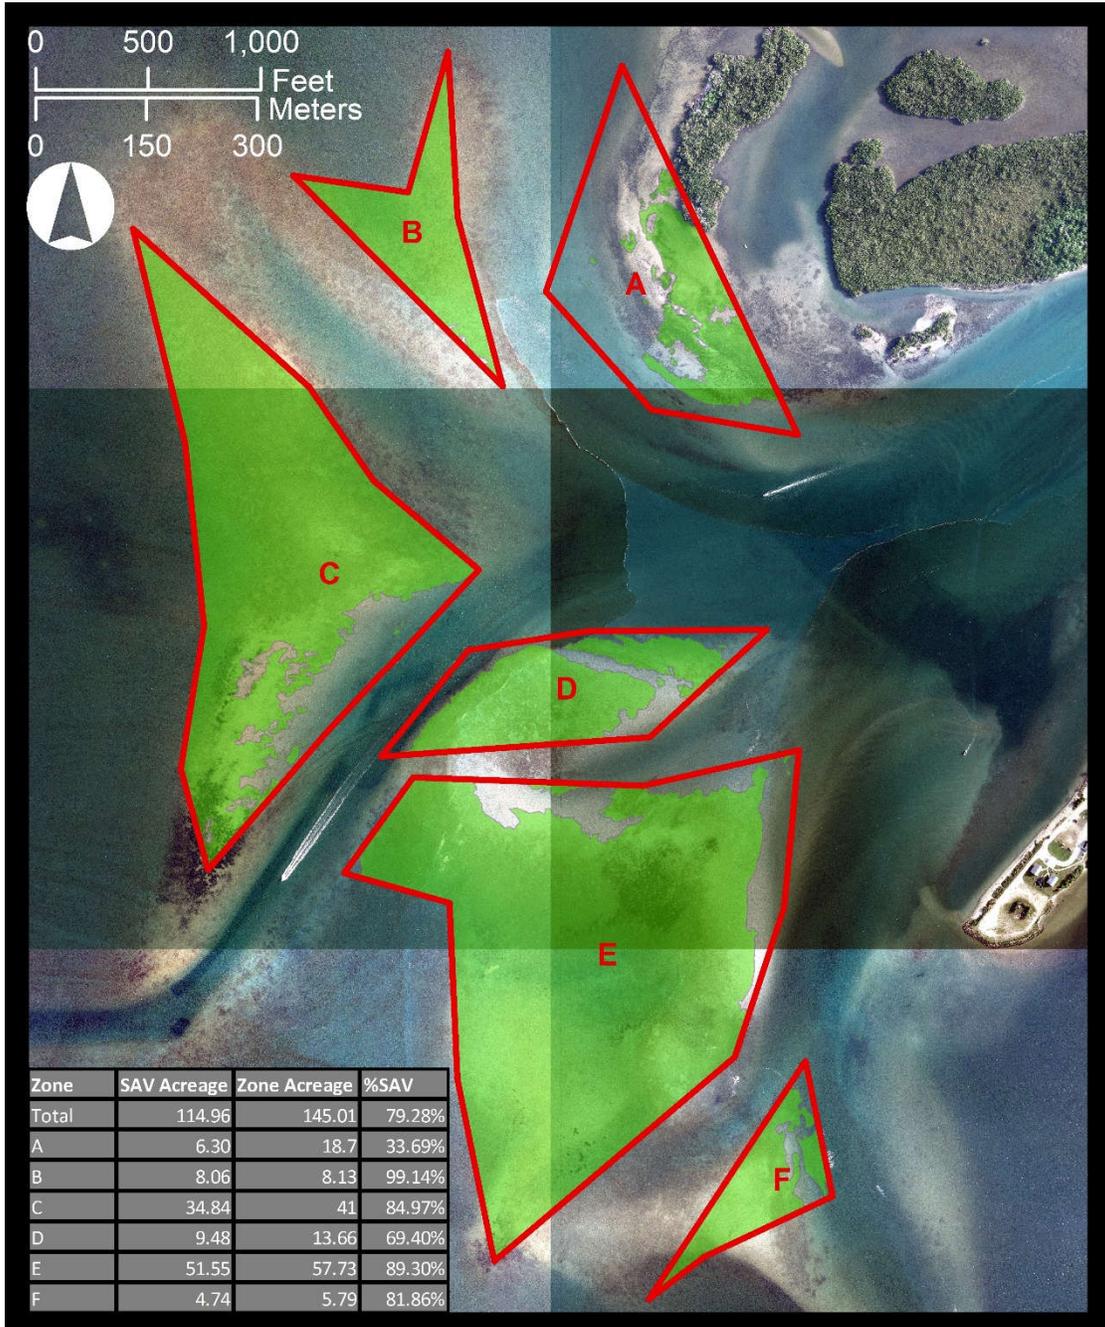
The finalized seagrass coverage feature class (post-groundtruthing) yielded ~114.96 acres of seagrass in 2020, equivalent to 79.28% of the mitigation zone (Figure 2-2). Zone-specific seagrass acreage estimates ranged from 4.74 acres (Zone F) to 51.55 acres (Zone E) with percent cover values (i.e., the percentage of the zone area covered by seagrass) from 33.69% (Zone A) to 99.14% (Zone B). A complete listing of 2020 zone values can be found in the inset table of Figure 2-2.

Figure 2-2. ESRI feature class depicting the estimated extent of seagrass within the mitigation zone in 2020. The associated table summarizes area and percent coverage of seagrass by zone. Aerial image taken July 1, 2020

GIS dataset can be seen in Figure 2-2 and was used in all acreage calculations reported within this document.

- 2020 Results
 - The finalized seagrass coverage feature class (post-groundtruthing) yielded ~114.96 acres of seagrass in 2020, equivalent to 79.28% of the mitigation zone. Zone A had the least coverage of seagrass (33.69% of the zone occupied by seagrass) while Zone B had the greatest (99.14% of the zone occupied by seagrass).
 - Species-specific data revealed that ~49% of the sites that contained seagrass were monospecific patches of seagrass, including *Halodule wrightii* (30%), *Halophila johnsonii* (15%), and *Syringodium filiforme* (4%). The remaining ~51% consisted of species combinations, including *H. wrightii*, *H. johnsonii*, *H. decipiens*, *H. engelmannii*, and *Syringodium filiforme*. *H. wrightii*/*H. johnsonii* was the predominant species combination at 43%.
 - No prop scars were field validated in 2020.

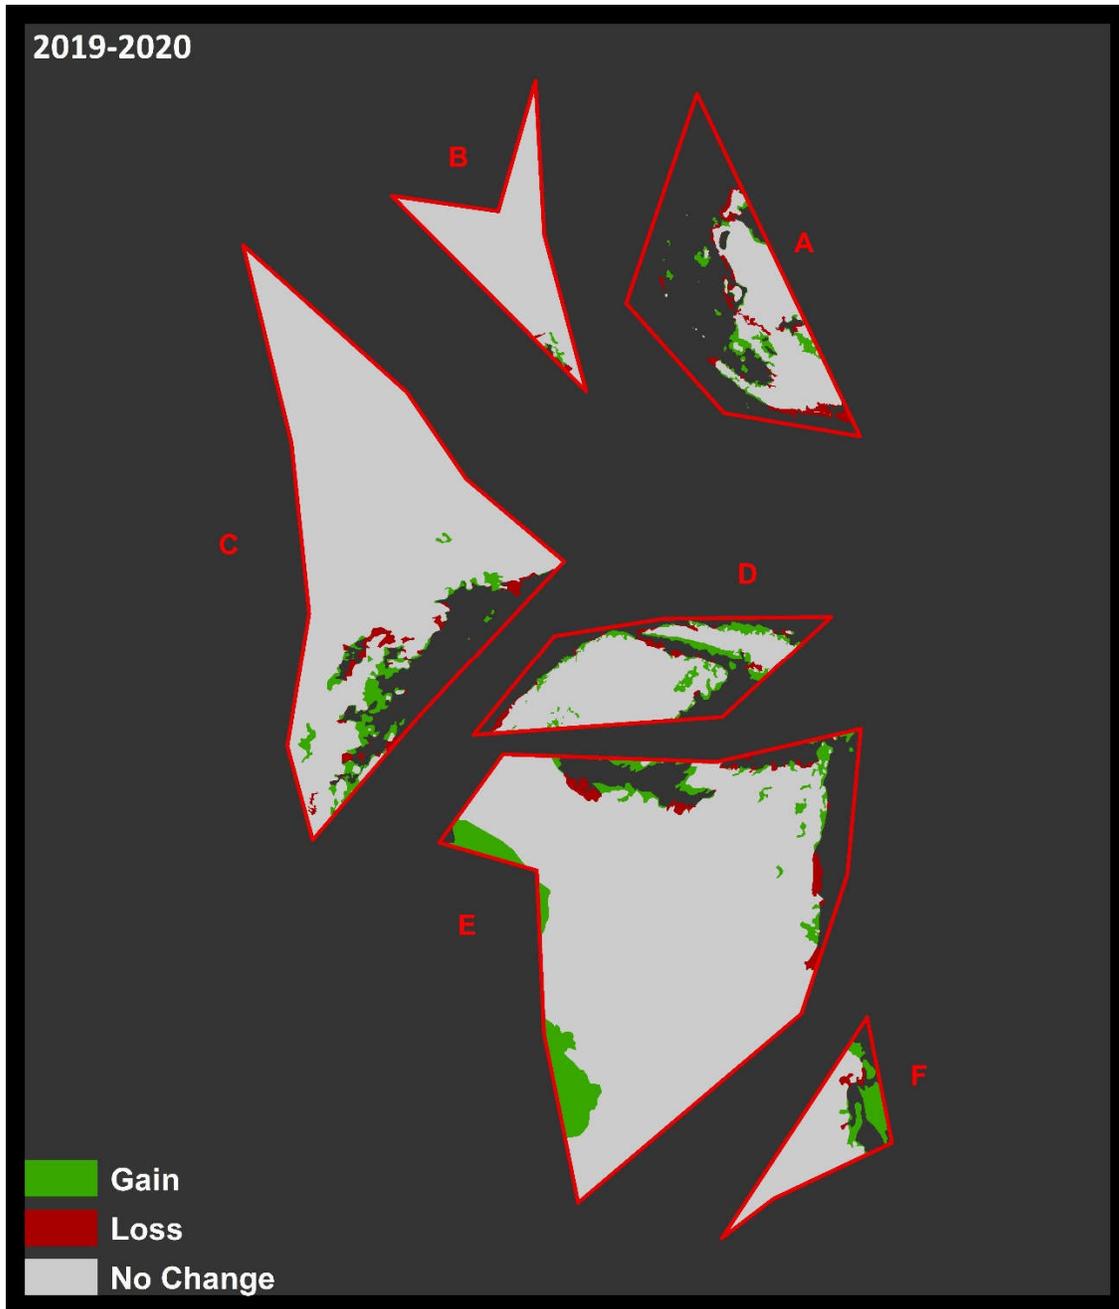
To estimate changes in the distribution of seagrass within the flood tidal shoal, finalized seagrass coverage feature classes were compared between 2019 and 2020 for regions of “Gain” and “Loss.” ESRI ArcGIS 10.5.1 was used to cut the areas of non-overlap from alternating comparisons of the two datasets, leaving a remaining portion as a static region of “No Change.” A visual depiction of these changes can be seen in Figure 2-3.

Figure 2-3 Spatial distribution of inter-year change in seagrass coverage within the mitigation boundaries. Gains are depicted as - green, losses - red, and areas consistent between years - gray. Analysis included 2019 and 2020 data.

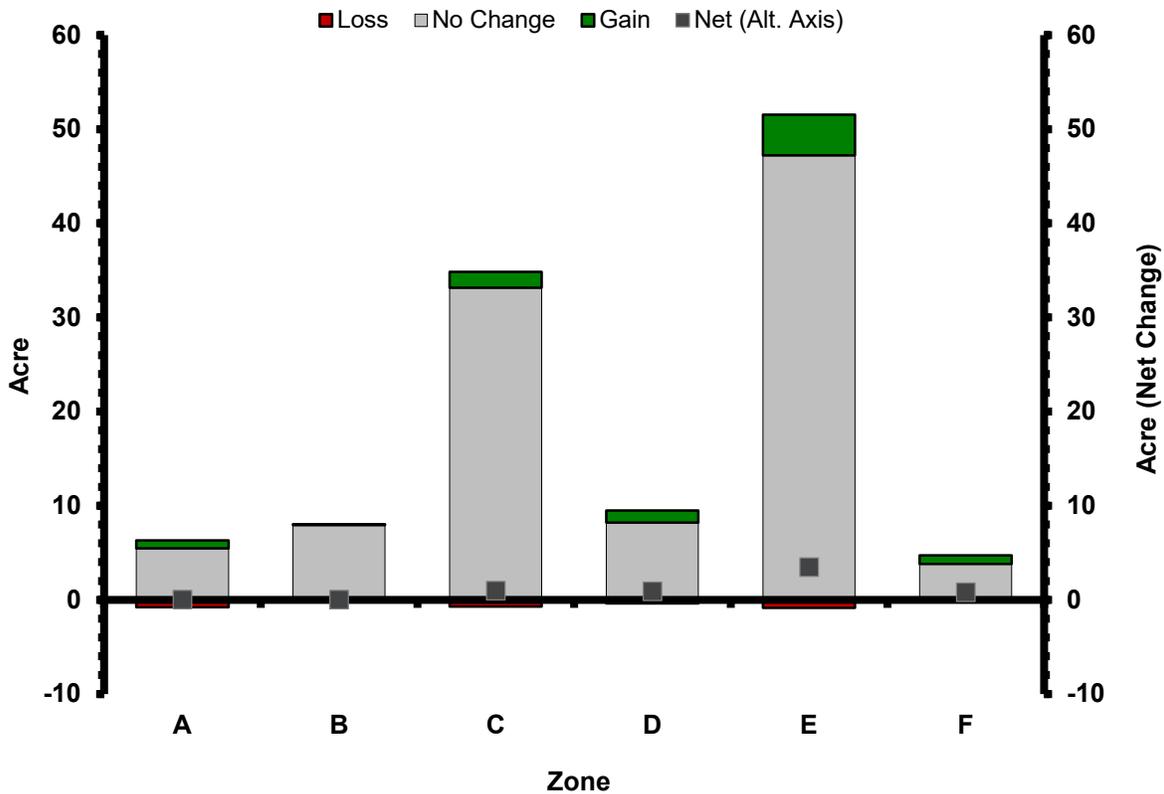
From 2019 to 2020, there was an increase in seagrass shoal-wide of ~6.24 acres. All zones exhibited net increases in seagrass coverage ranging from 0.04 acres (Zones A and B) to 3.48 acres (Zone E) (Figure 2-4). Zones E and F respectively had the highest and lowest total acreage of seagrass in both 2019 and 2020; however, this is unsurprising as these are respectively the largest and smallest shoals. In terms of percent coverage of the zone occupied by seagrass, Zone B had the highest coverage in both 2019 and 2020, while Zone A had the lowest coverage in both years. Zone A has experienced erosion of sediment along the southwest facing edge since 2012 preventing seagrass reestablishment in the deeper, eroded areas.

Figure 2-4 Zone-specific changes in seagrass cover (acres) between 2019 and 2020. Net change in total acreage depicted on alternate axis.

- 2019-2020 Results
 - From 2019 to 2020, there was an increase in seagrass shoal-wide of ~6.24 acres. All zones exhibited net increases in seagrass coverage ranging from 0.04 acres (Zones A and B) to 3.48 acres (Zone E).

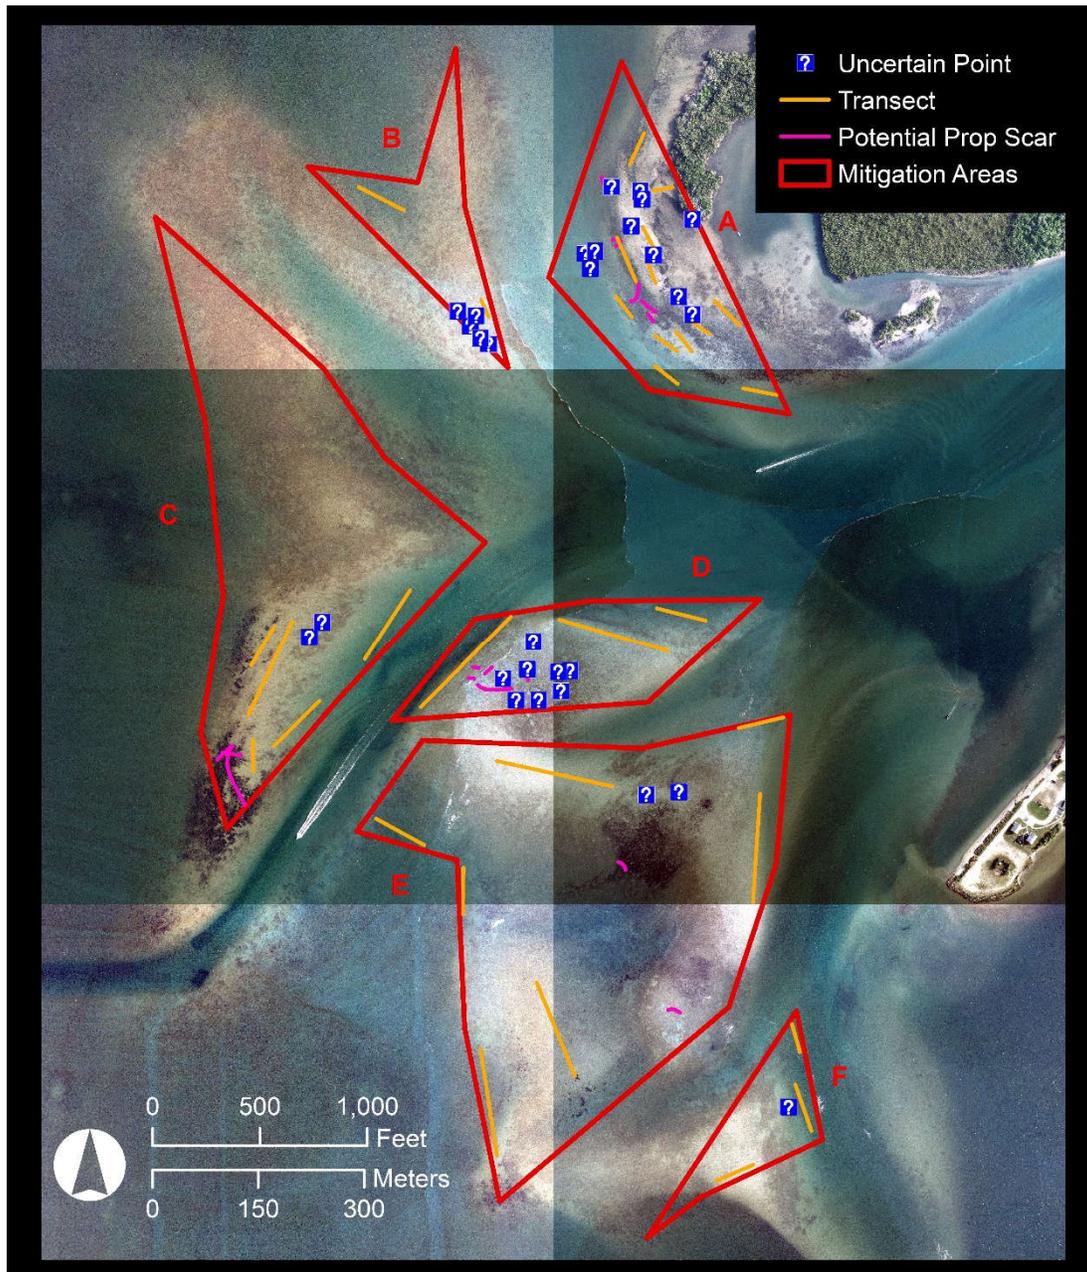
To estimate the quantity of anthropogenic impact within the mitigation zone in 2020, biologists systematically examined the 2020 aerial photography at an absolute resolution of 1:400 to 1:500 for the presence of linear and otherwise un-natural features on the shoal (i.e., prop scars). The potential prop scars digitized from the aerial imagery were uploaded to ESRI Collector which was used for data collection and navigation purposes during the groundtruthing effort (Figure 3-1).

During the August 11-13, 2020 groundtruthing effort, biologists used ESRI Collector to visit the 16 potential prop scar locations identified in the July 1, 2020 aerial image, assessing them for validity. No prop scars were field verified from the aerial imagery. This is a change from 2019, when 34 prop scars were field-validated; however, prior to 2019 the number of prop scars validated during survey events was typically low.

A total of 32 groundtruthing transects were also identified during the aerial image analysis (Figure 3-1). These groundtruthing transects were uploaded to ESRI Collector. Biologists visited each transect and performed a broad assessment of the bottom type including seagrass species identification (where applicable). The polyline feature class was then appended on site. In certain instances, point data were also collected along the transects to signal a change in benthic composition (e.g., seagrass presence/absence or seagrass species observed).

Figure 3-1 Location of potential prop scars, points of uncertainty, and groundtruthing transects visited during the 2020 groundtruthing event. Aerial image taken July 1, 2020.

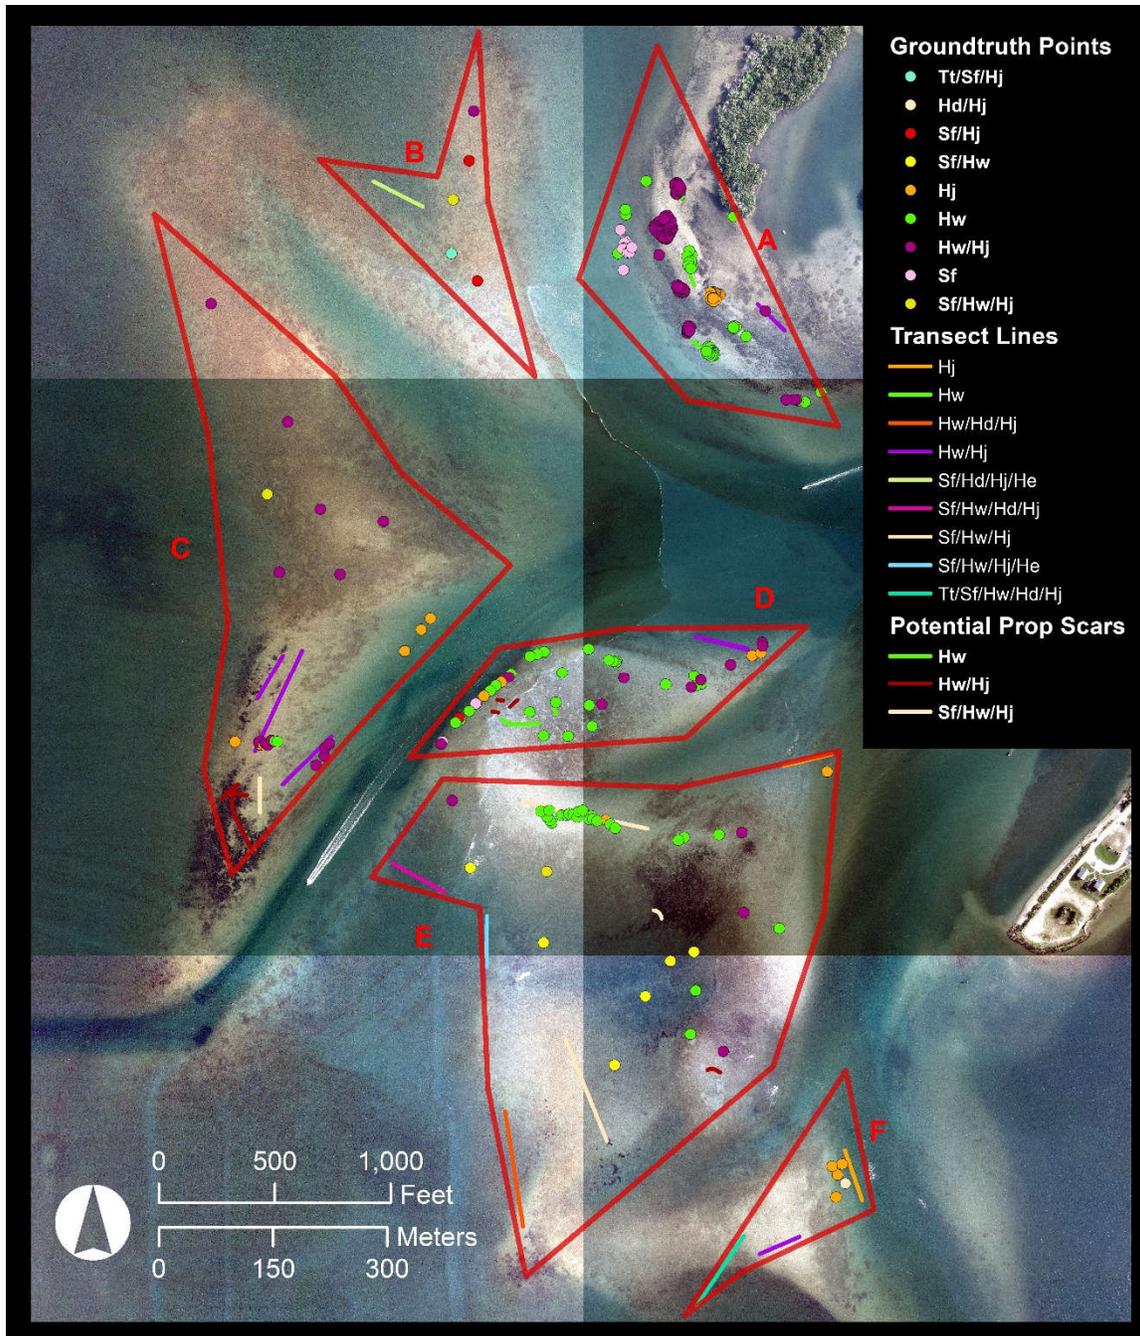
All positions identified during the image analysis, as well as additional seagrass data collected during the groundtruthing event, were sampled for benthic composition (N=360 positions). Approximately 91% of these positions (N=327)¹ contained seagrass species (Figure 3-2). The remaining ~9% consisted of shell material (Figure 3-3), cyanobacteria, sand, worm tubes, and macroalgae (*Caulerpa* sp., see photo in Figure 3-3). Figure 3-2 depicts the locations of seagrass species/species combinations observed on the shoal in 2020. Species-specific data revealed that ~49% of the sites that contained seagrass were monospecific patches of seagrass, including *Halodule wrightii* (30%), *Halophila johnsonii* (15%), and *Syringodium filiforme* (4%). The remaining ~51% consisted of species combinations, including *H. wrightii*/*H. johnsonii* (the predominant species combination at 43%), *S. filiforme*/*H. wrightii* (2%), *S. filiforme*/*H. wrightii*/*H. johnsonii* (2%), and *S. filiforme*/*H. johnsonii* (1%), with the remaining 3% being accounted for by single observances of other combinations (see Figure 3-4 photographs of seagrass species observed).

Figure 3-2. Locations of seagrass species and species combinations observed during the 2020 groundtruthing event. Abbreviations Hj = *Halophila johnsonii*, Hw = *Halodule wrightii*, Hd = *Halophila decipiens*, Sf = *Syringodium filiforme*, Tt = *Thalassia testudinum*, He = *Halophila engelmannii*.

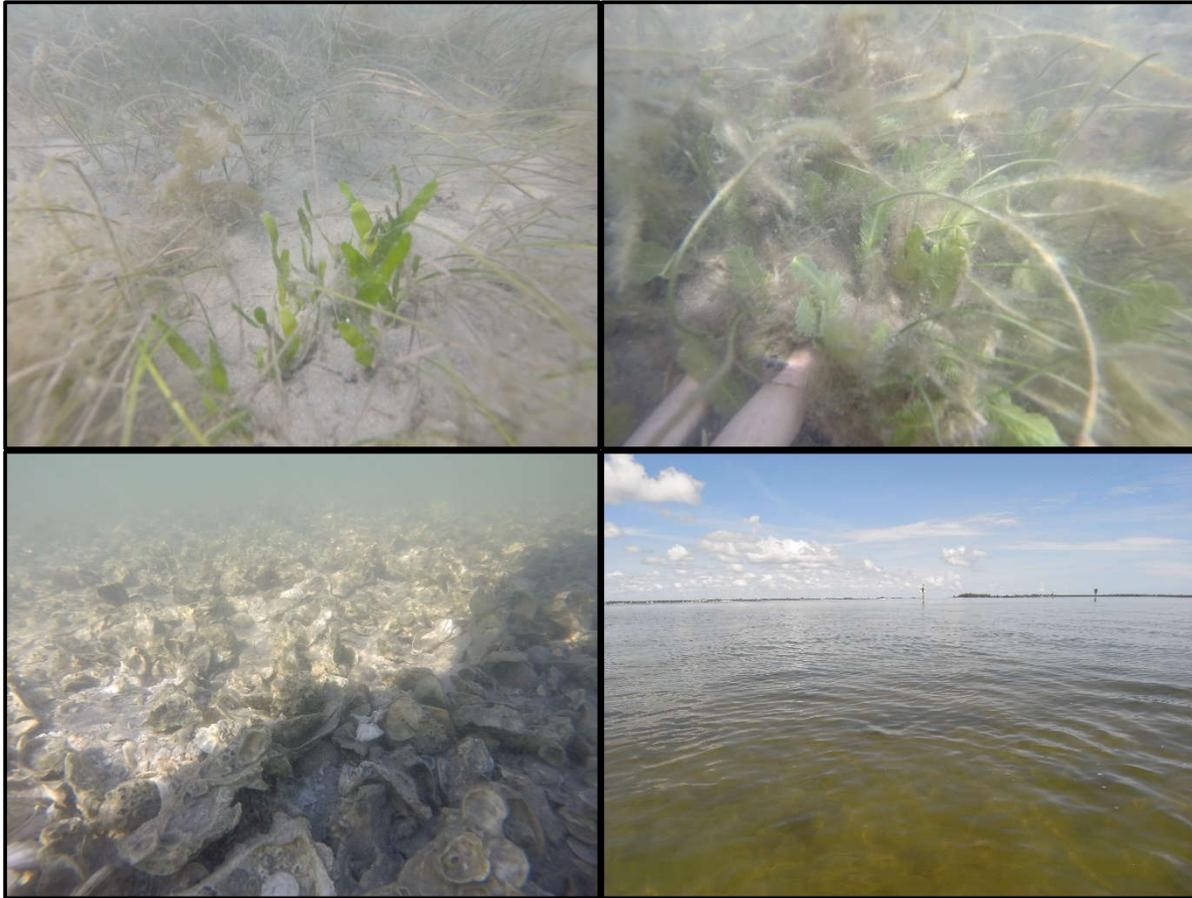
Figure 3-3. Other features observed during 2020 groundtruthing effort – *Caulerpa prolifera* surrounded by *Halodule wrightii* (upper left); *Caulerpa sertularoides* surrounded by *Syringodium filiforme* (upper right); bottom covered with oyster shell (lower left); and tannic water at low tide (lower right).

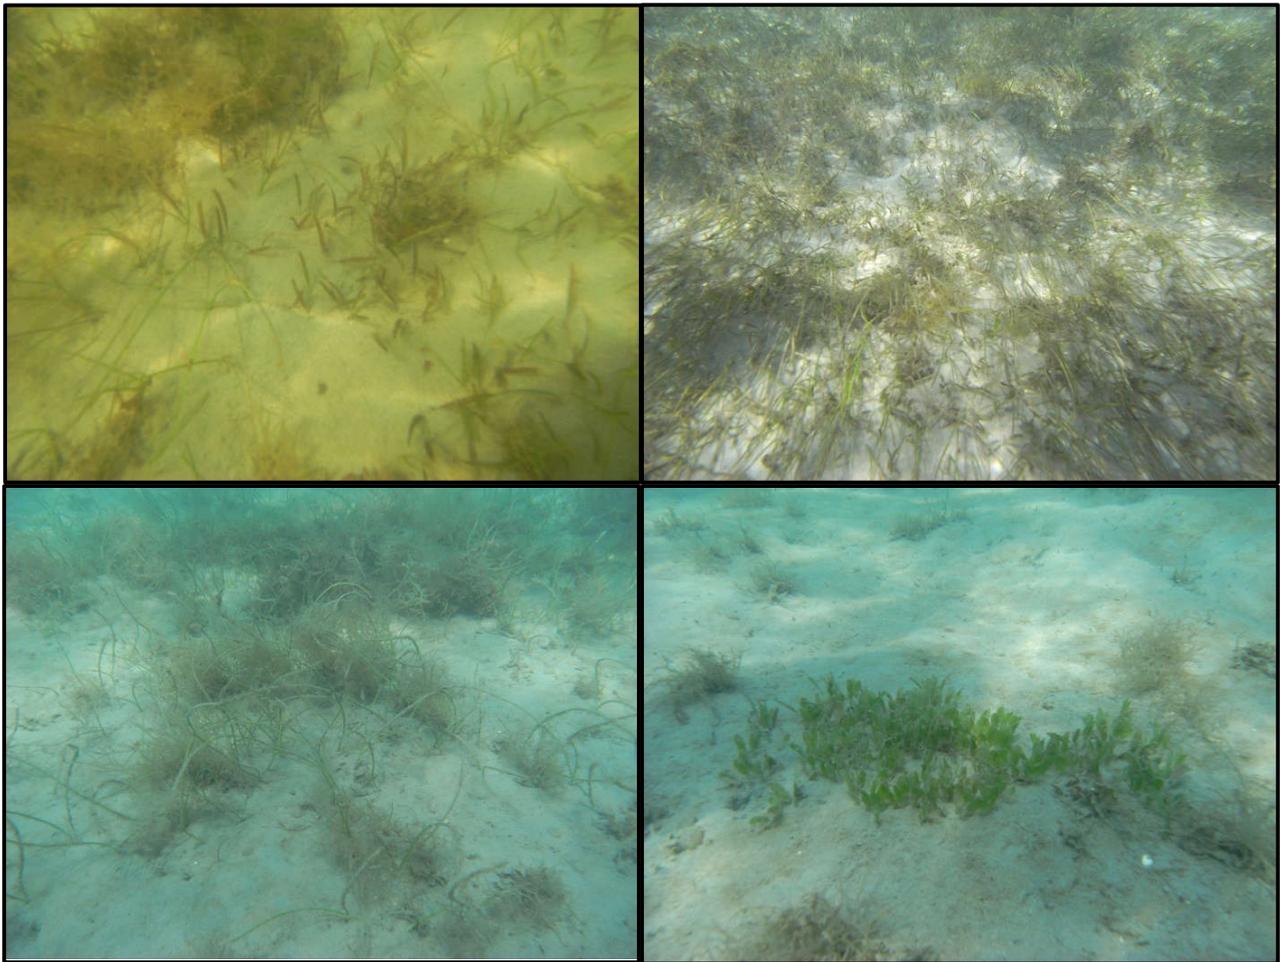
Figure 3-4. The seagrass species found on the shoal in 2020 – *Halophila johnsonii* and *Halodule wrightii* (upper left and right); *Syringodium filiforme* (lower left); and *Halophila decipiens* (lower right).

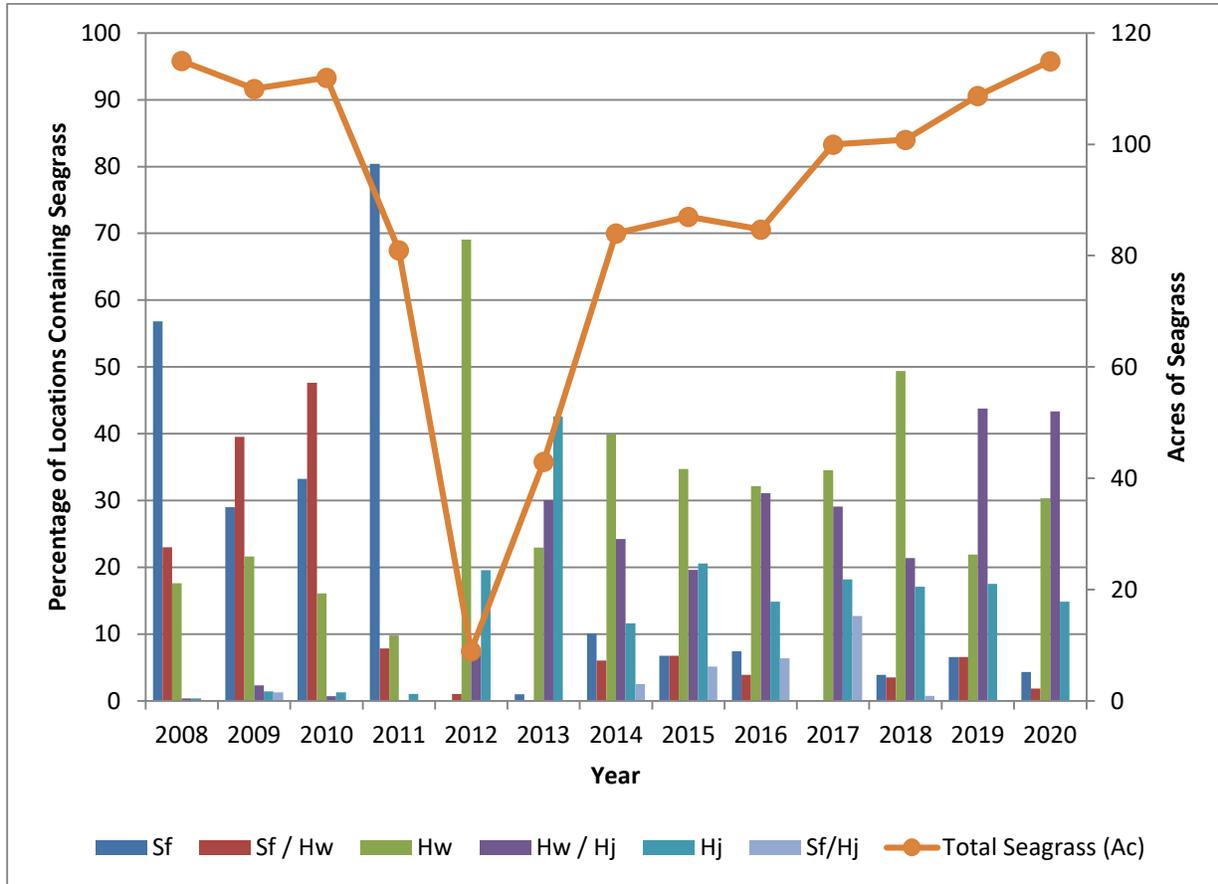
Differences were observed when comparing predominant seagrass species/species combinations on the flood tidal shoal over time. In the past (2008-2011), the flood tidal shoal was predominately *Syringodium filiforme*, *Halodule wrightii*, and combinations of the two species (Figure 3-5). *Halophila johnsonii* was only observed at a small percentage of locations. In 2012 and 2013 (beginning of seagrass recovery after region-wide seagrass loss), the dominant seagrass species on the flood tidal shoal were *H. johnsonii*, *H. wrightii*, and combinations of the two species (Figure 3-5). In 2014-2020, *H. wrightii* and *H. johnsonii* continue to be the predominant seagrass species; however, *S. filiforme* appears to be returning to the shoal (Figure 3-5).

Figure 3-5. Predominant seagrass species/species combinations observed from 2008 to 2020 showing the effects of and recovery after the region-wide seagrass loss. Abbreviations: Sf = *Syringodium filiforme*, Sf/Hw = *S. filiforme/Halodule wrightii*, Hw = *H. wrightii*, Hw/Hj = *H. wrightii/Halophila johnsonii*, Hj = *H. johnsonii*, and Sf/Hj = *S. filiforme/H. johnsonii*. Total seagrass acreage within the mitigation zone displayed on the secondary y-axis.

- The total acreage of seagrass present in 2020 slightly exceeds the acreage present in 2008 (115 ac), 2009 (110 ac), and 2010 (112 ac) – the three years prior to the region-wide seagrass loss in 2011 and 2012. However, while total acreage of seagrass is now roughly comparable to pre-loss coverage, the species composition has undergone a drastic shift. In the past (2008-2011), the flood tidal shoal was predominately *Syringodium filiforme*, *Halodule wrightii*, and combinations of the two species. In 2012 and 2013 (beginning of seagrass recovery after region-wide seagrass loss), the dominant seagrass species on the flood tidal shoal were *H. johnsonii*, *H. wrightii*, and combinations of the two species. In 2014-2020, *H. wrightii* and *H. johnsonii* continue to be the predominant seagrass species; however, *S. filiforme* appears to be returning to the shoal.

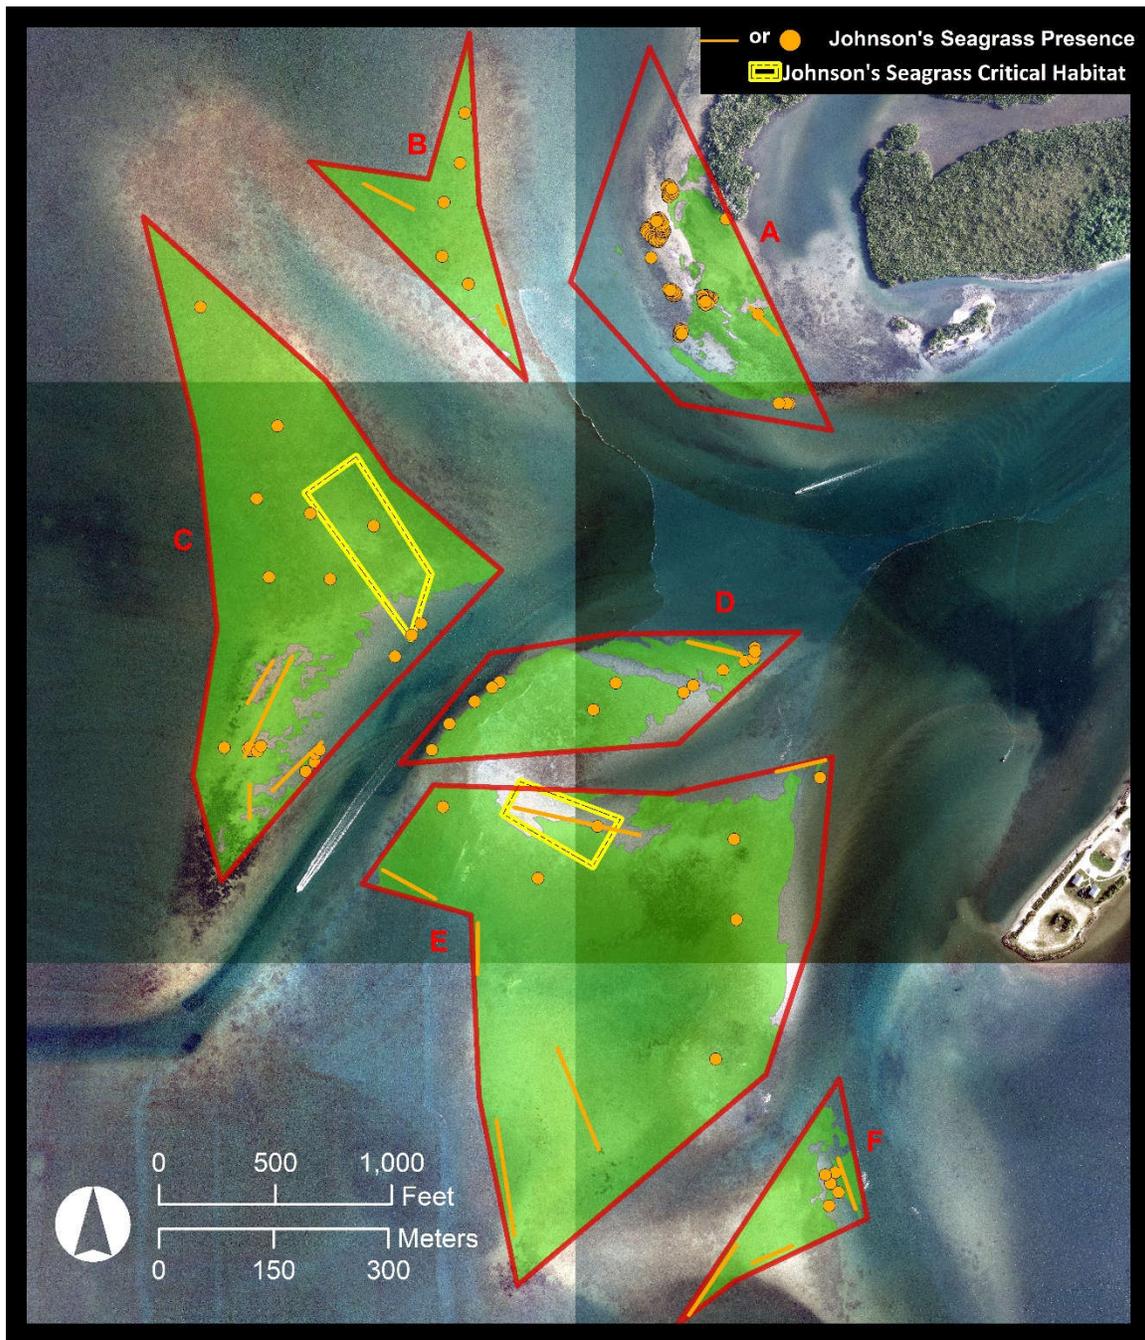
According to the Endangered Species Act (ESA), *Halophila johnsonii* is listed as a threatened species (listed on September 14, 1998) throughout the range of the species from central Biscayne Bay to Sebastian Inlet. The ESA requires the federal government to designate “critical habitat” for any listed species. The designation provides explicit notice to federal agencies and the public that these areas are vital to the conservation of the species. Critical habitat for *H. johnsonii* was established on April 5, 2000 and includes ten locations between Sebastian Inlet and Biscayne Bay. Because areas located north and south of the Sebastian Inlet channel are considered *H. johnsonii* critical habitat, a separate figure was created, clearly showing the distribution of *H. johnsonii* within the mitigation zone in 2020 and the designated critical habitat areas (Figure 3-6). *H. johnsonii* (or a species combination including *H. johnsonii*) was present at ~64% of all sites that contained seagrass in 2020, which is comparable to the 2019 survey (~65% of all sites). *H. johnsonii* has been significant in the recovery of seagrasses on the flood tidal shoal and the stability of the shoal as seagrasses recolonize.

Figure 3-6. Locations with *Halophila johnsonii* observed during the 2020 groundtruthing event.

- *H. johnsonii* (or a species combination containing *H. johnsonii*) was present at ~64% of all sites that contained seagrass in 2020, which is comparable to the 2019 survey (~65% of all sites). *H. johnsonii* has been significant in the seagrass recovery on the flood tidal shoal and the stability of the shoal as seagrasses recolonize.
