Sebastian Inlet Seagrass Monitoring Program

2021 Annual Seagrass Monitoring Report

Sebastian Inlet District

14 March 2022

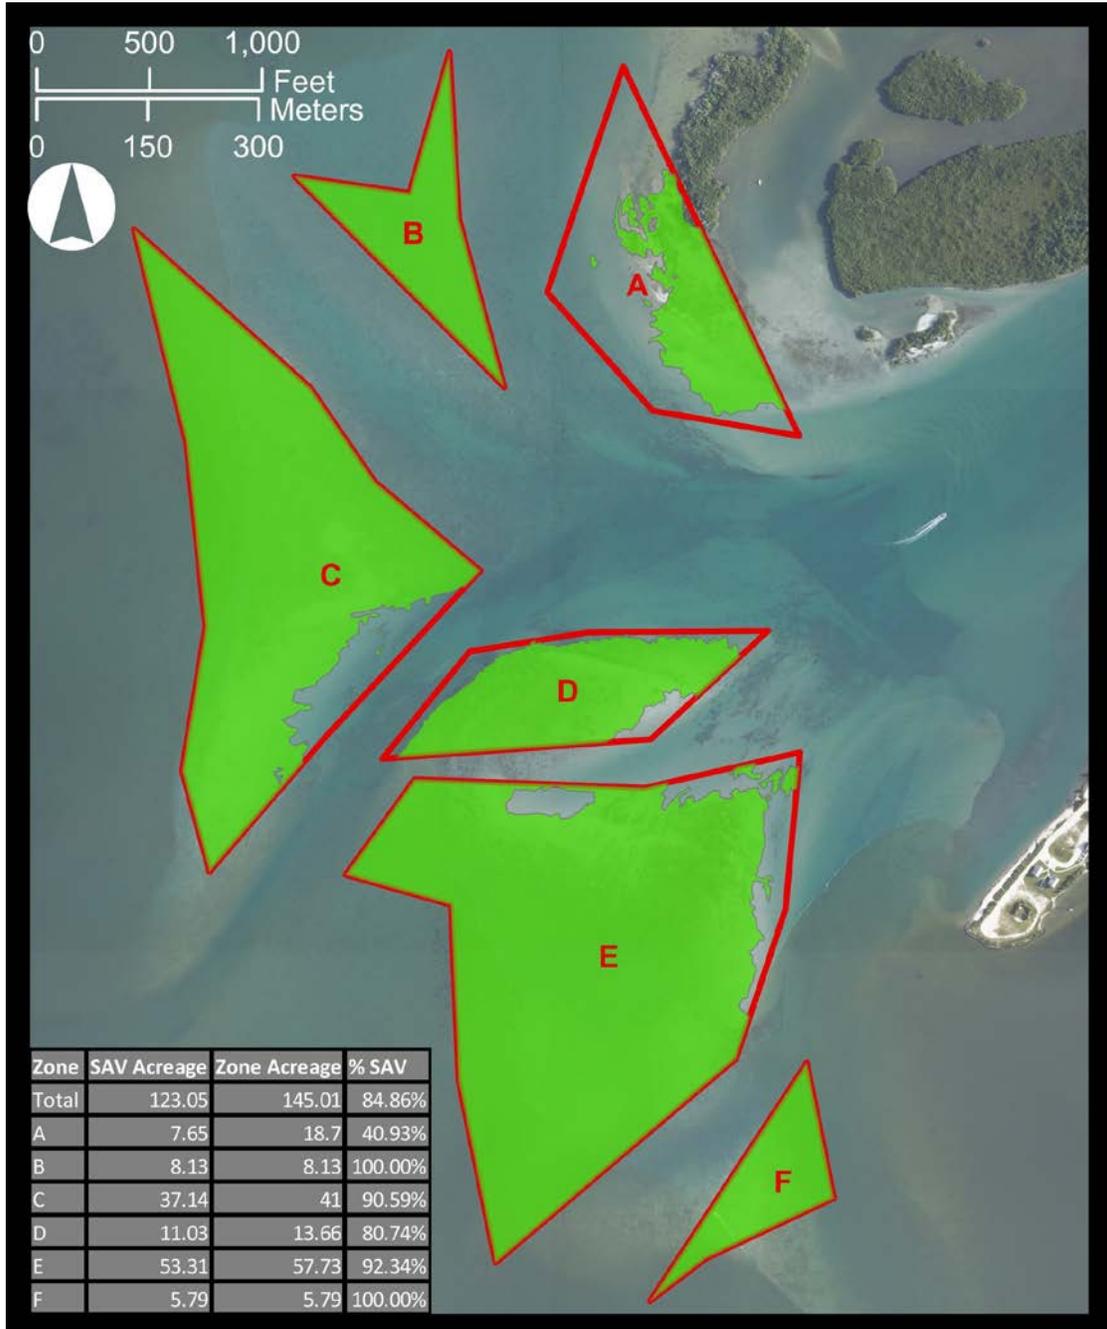
The finalized seagrass coverage feature class (post-groundtruthing) yielded ~123.05 acres of seagrass in 2021, equivalent to 84.86% of the mitigation zone (Figure 2-2). Zone-specific seagrass acreage estimates ranged from 5.79 acres (Zone F) to 53.31 acres (Zone E) with percent cover values (i.e., the percentage of the zone area covered by seagrass) from 40.93% (Zone A) to 100% (Zones B and F). A complete listing of 2021 zone values can be found in the inset table of Figure 2-2.

Figure 2-2. ESRI feature class depicting the estimated extent of seagrass within the mitigation zone in 2021. The associated table summarizes area and percent coverage of seagrass by zone. Aerial image taken August 5, 2021.

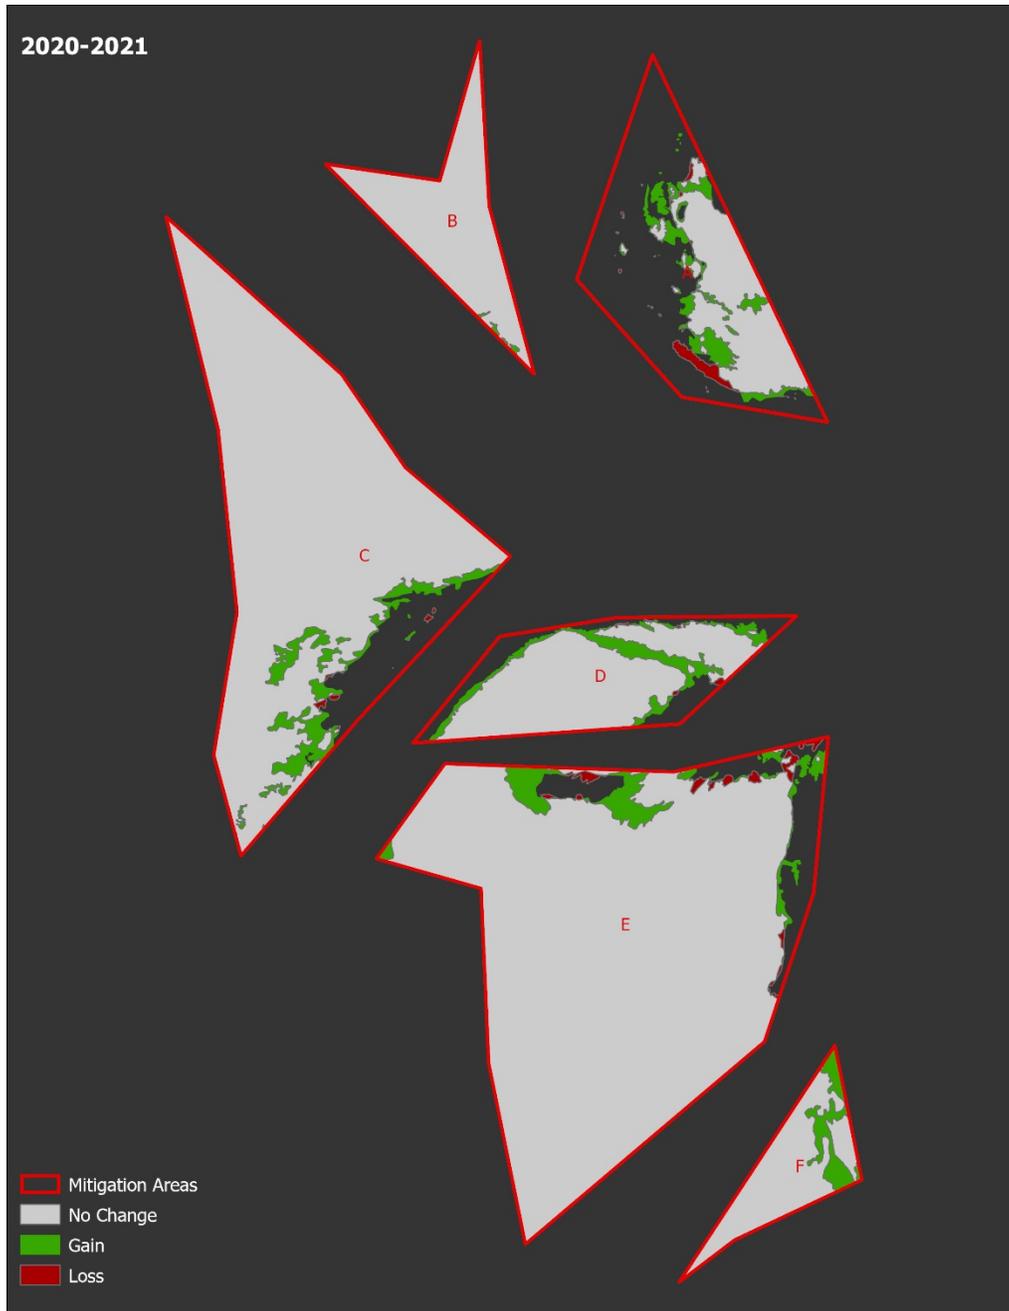
To estimate changes in the distribution of seagrass within the flood tidal shoal, finalized seagrass coverage feature classes were compared between 2020 and 2021 for regions of “Gain” and “Loss.” ESRI ArcGIS Pro was used to cut the areas of non-overlap from alternating comparisons of the two datasets, leaving a remaining portion as a static region of “No Change.” A visual depiction of these changes can be seen in Figure 2-3.

Figure 2-3 Spatial distribution of inter-year change in seagrass coverage within the mitigation boundaries. Gains are depicted as - green, losses - red, and areas consistent between years - gray. Analysis included 2020 and 2021 data.

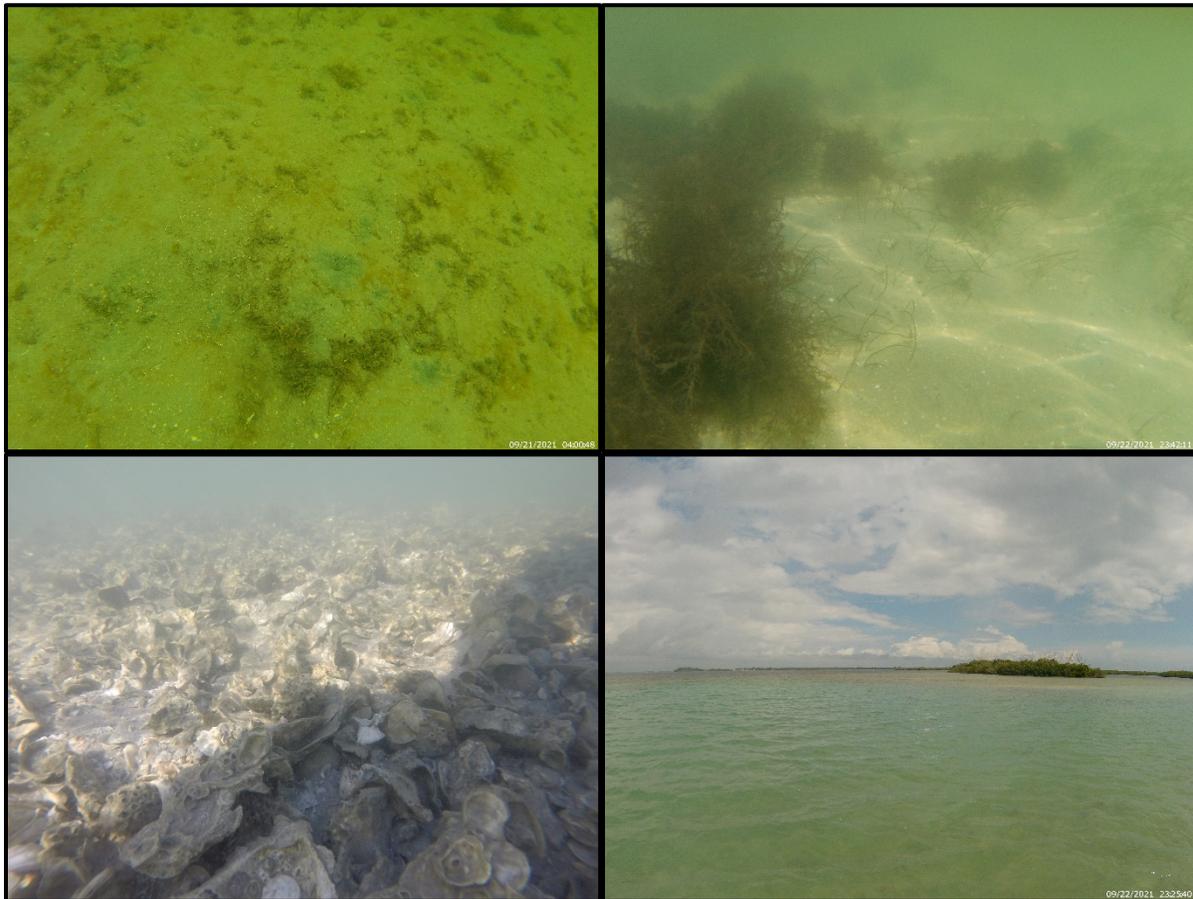
Figure 3-3. Other features observed during 2021 groundtruthing effort – mix of worm tubes and bottom detritus (upper left, Zone F); drift algae atop *Halodule wrightii* (upper right, Zone A); bottom covered with oyster shell (lower left, Zone A); and tannic water at low tide (lower right, background, Zone A).
