# Sebastian Inlet Seagrass Monitoring Program

## 2022 Annual Seagrass Monitoring Report

### Sebastian Inlet District

30 January 2023

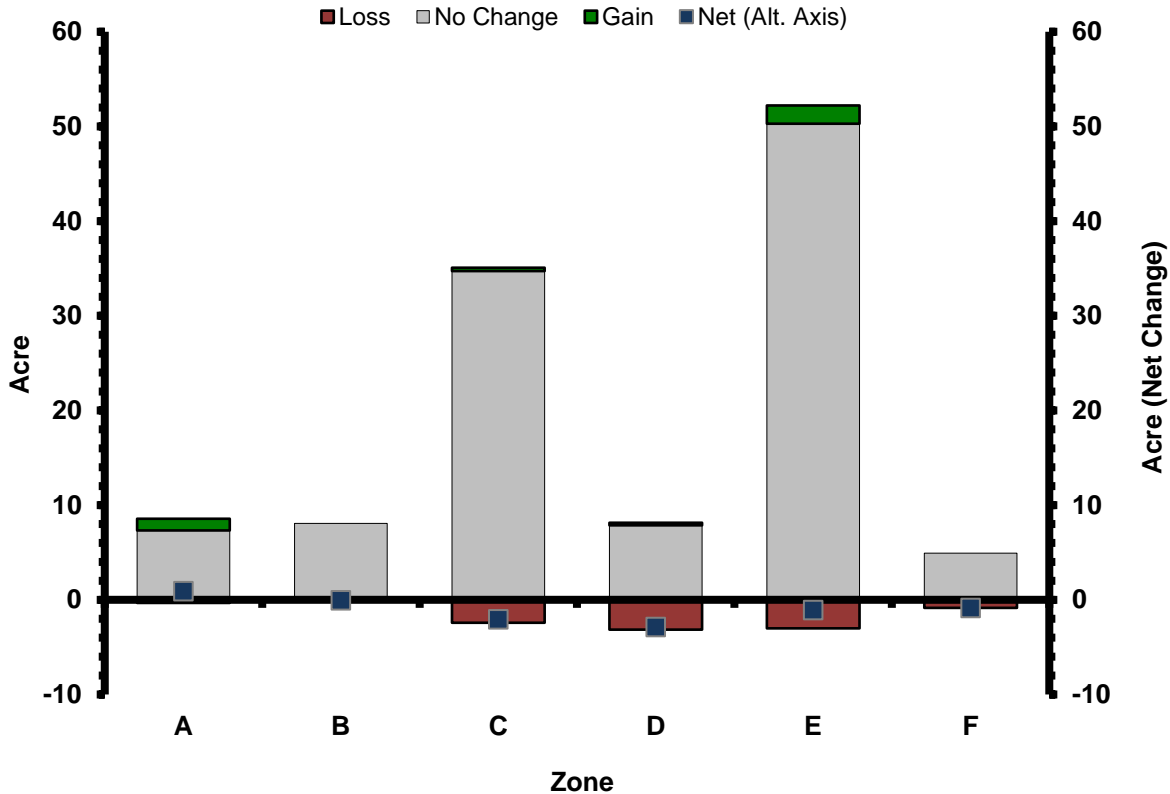
To estimate changes in the distribution of seagrass within the flood tidal shoal, finalized seagrass coverage feature classes were compared between 2021 and 2022 for regions of “Gain” and “Loss.” ESRI ArcGIS Pro was used to cut the areas of non-overlap from alternating comparisons of the two datasets, leaving a remaining portion as a static region of “No Change.” A visual depiction of these changes can be seen in Figures 2-4 and 2-5.

From 2021 to 2022, there was a decrease in seagrass shoal-wide of 6.03 acres. All zones except Zone A (net increase of 0.91 acres) exhibited net decreases in seagrass coverage ranging from 0.06 acres (Zone B) to 2.88 acres (Zone D) (Figure 2-4). Zones E and F respectively had the highest and lowest total acreage of seagrass in both 2021 and 2022; however, this is unsurprising as these are respectively the largest and smallest shoals. In terms of percent coverage of the zone occupied by seagrass, Zone B had the highest coverage in both 2021 and 2022 (equalled by Zone F in 2021), while Zone A had the lowest coverage in both years.

Figure 2-5. Zone-specific changes in seagrass cover (acres) between 2021 and 2022. Net change in total acreage depicted on alternate axis.

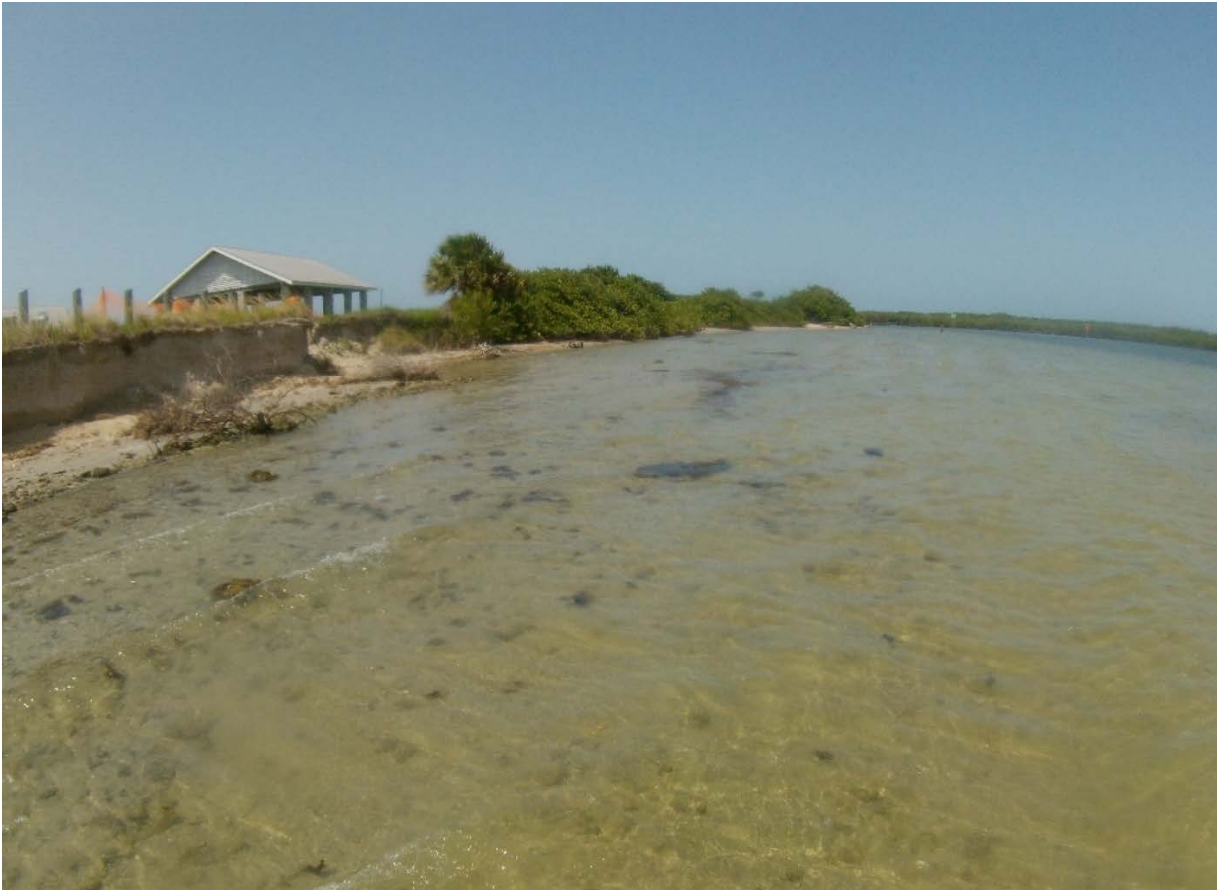
As an additional scope item for the 2022 monitoring event, SID requested the Atkins delineate the nearshore seagrass edge along the southeast side of Coconut Point (for a straight-line distance of approximately 600 linear feet), south of the Sebastian Inlet State Park boat ramp. The seagrass line was collected in the field using the R1 and ESRI Field Maps to collect a polyline feature tracing the inshore edge (Figure 3-8). The northern portion of this seagrass edge (approximately 380 linear feet) conformed to the shoreline, with the southern edge being 25-65 ft offshore. The shoreline edge along the southern part of this line is severely eroded, with rubble strewn between the current shoreline and the nearshore seagrass edge. Most likely, the offset is due to erosion of the shoreline, rather than recession of the seagrass edge. Species composition was sparse (~30% coverage) *Halodule wrightii*; clumps of cyanobacteria were observed attached to the grass blades, indicating some level of stress on the grass.

**Figure 3-8.** Coconut Point shoreline viewed from the south end of the assessment area, looking northeast along the shoreline. Erosion at south end of the shoreline and cyanobacteria growing on seagrass and rubble visible.

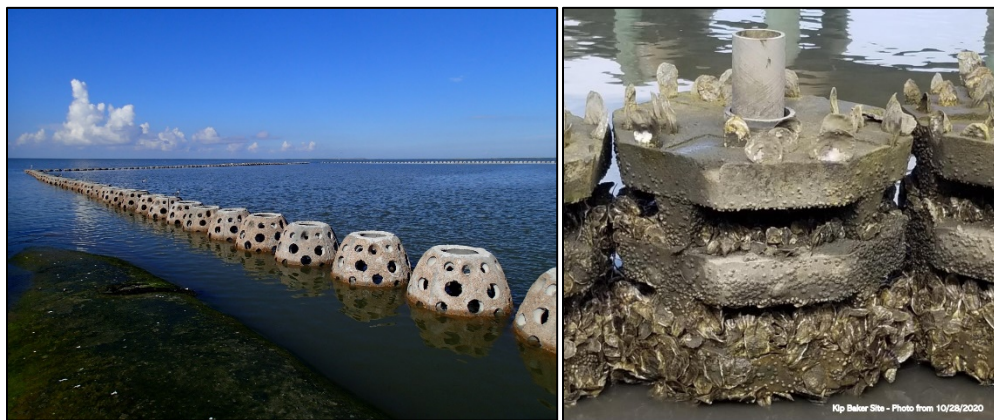
Some hybrid living shorelines incorporate oyster products, which primarily consist of free-standing modular concrete cast units that can be submerged or placed in the intertidal zone. The oyster products can be placed individually or used to create breakwaters by aligning the modular units into segmented structures located parallel to the shoreline. Prior to implementing oyster products, it is important to understand if the area has historically had oysters, and if the salinity and other conditions are appropriate for oyster success.

**Figure 5-1. Example of concrete cast oyster products – Reef Innovations Reef Balls (left); Reef Maker Wave Attenuator (right).**
